HOME INSPECTION REPORT

2524 PAMPLONA ST, PHARR, TX 78577

9/2/2020

PHARR-09022020-3

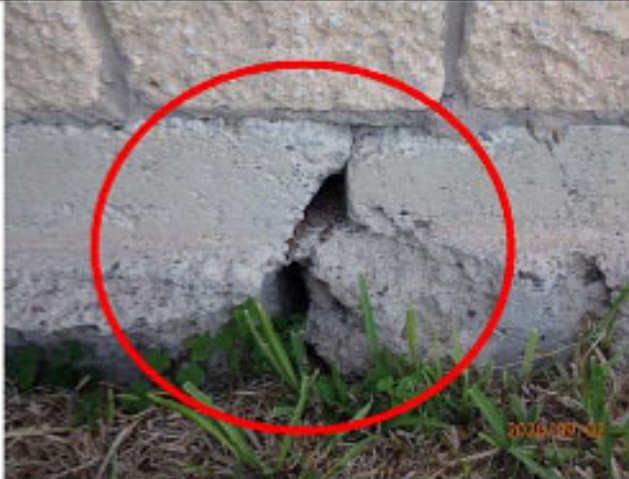
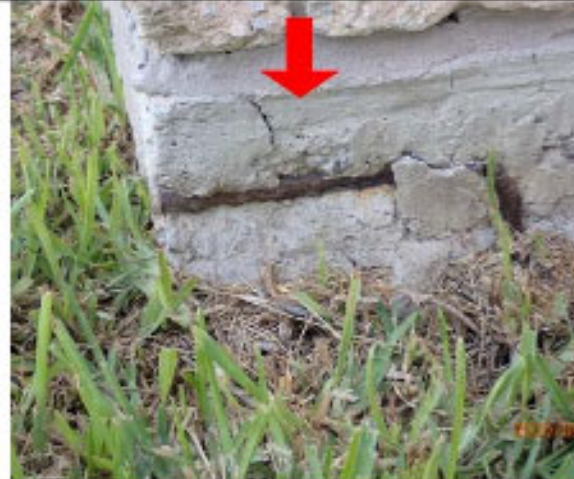
- Foundation wall mortar joints show evidence of deterioration. It would be wise to consider re patching deteriorated areas in order to improve durability.

Foundation wall mortar joints show evidence of deterioration.

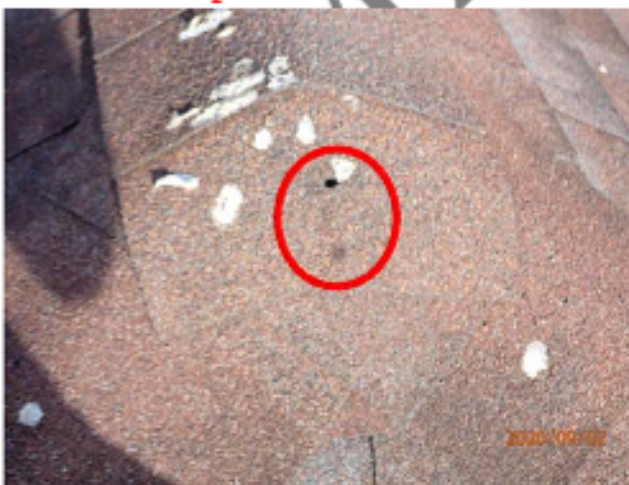
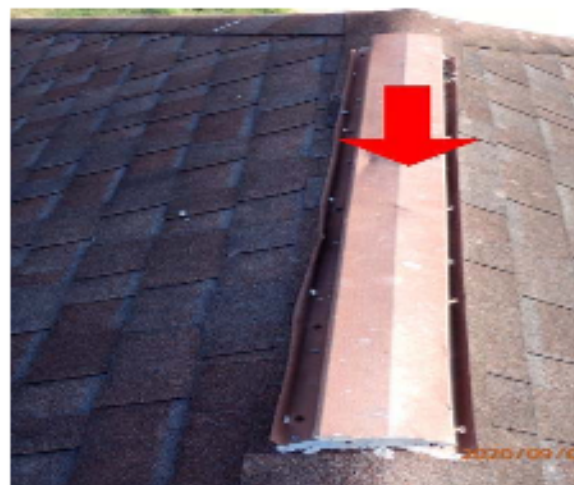
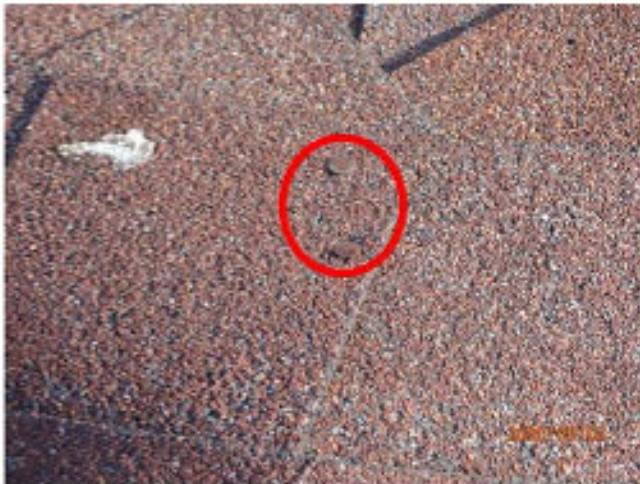
- Nail heads are exposed at the ridge. They should be sealed to reduce risk of leaks, recommend a professional roofer company to inspect and make necessary repairs.

Nail heads are exposed at the ridge.

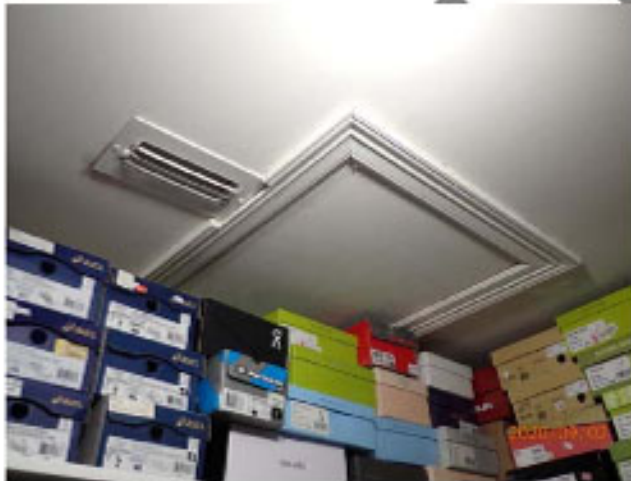
- Attic hatch was inaccessible to enter and inspect the attic.

- unable to comment due to attic been inaccessible.

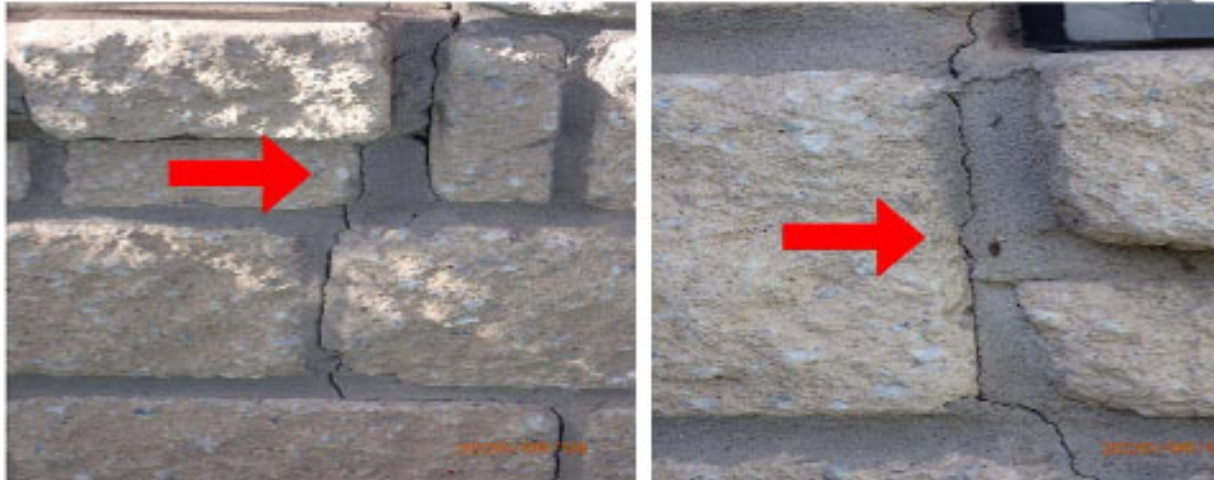
- Minor cracks were noted. This condition is mainly cosmetic in nature and should be patched.

Minor cracks were noted.

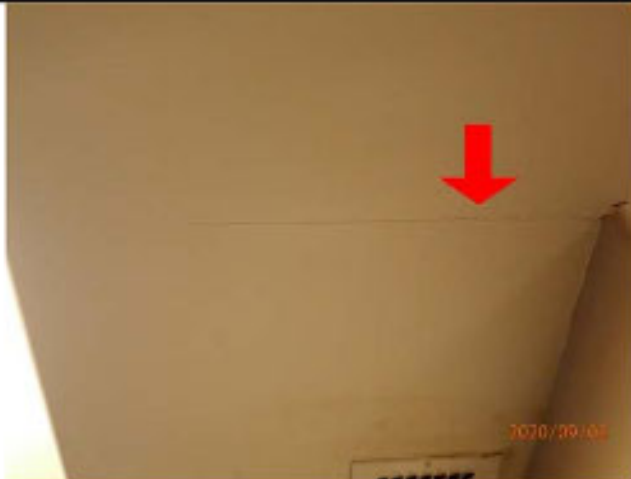
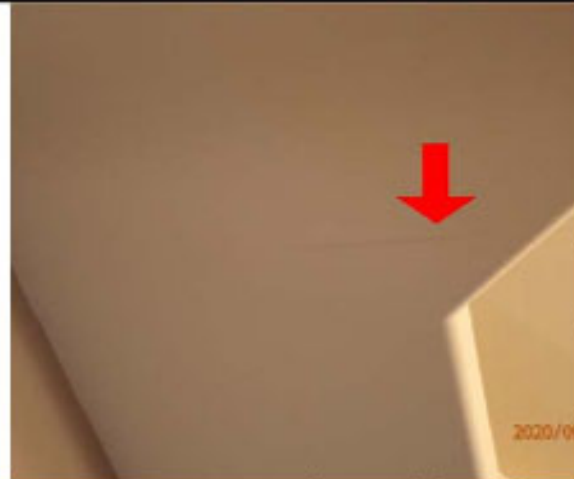
- Minor cracks were noted on the second floor ceiling. This condition is mainly cosmetic in nature and should be patched.

Minor cracks were noted on the second floor ceiling.

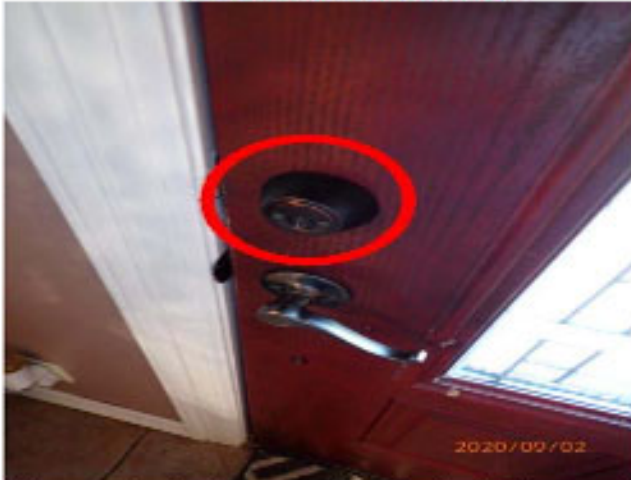
- All egress door hardware should be single cylinder, should be open from inside without a key, these is a safety concerned, recommend a professional locksmith to make necessary repairs.

All egress door hardware should be single cylinder.

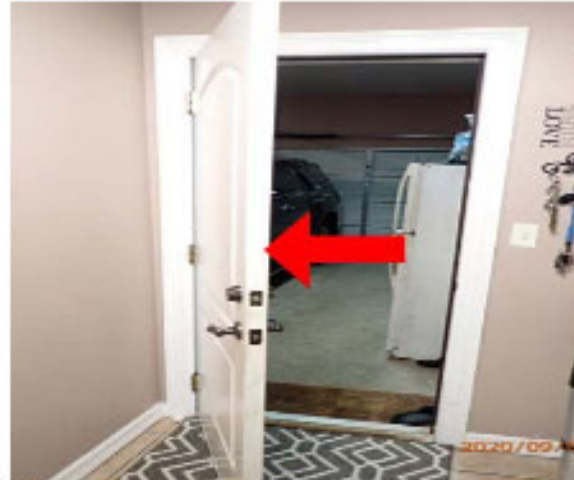
- Garage entrance door to the house should be on a self-closing hinge, these will help prevent fumes coming into the conditioning space.

Garage entrance door to the house should be on a self-closing hinge.

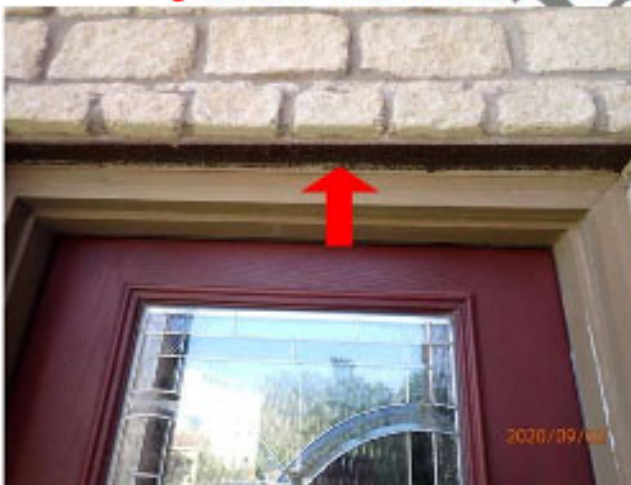
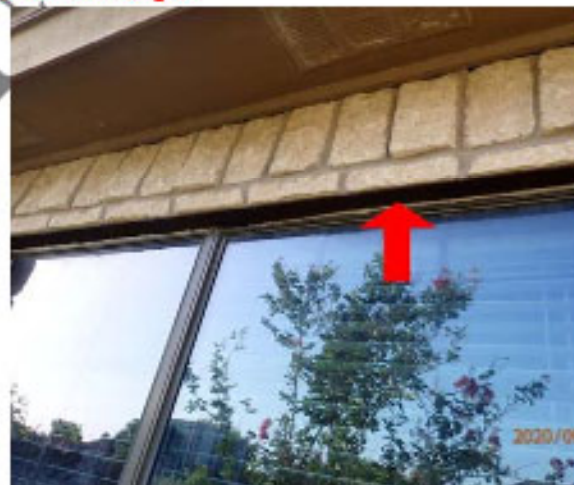
- Window Lintel should be painted to prevent rust and structural damage.

Window Lintel should be painted to prevent rust.

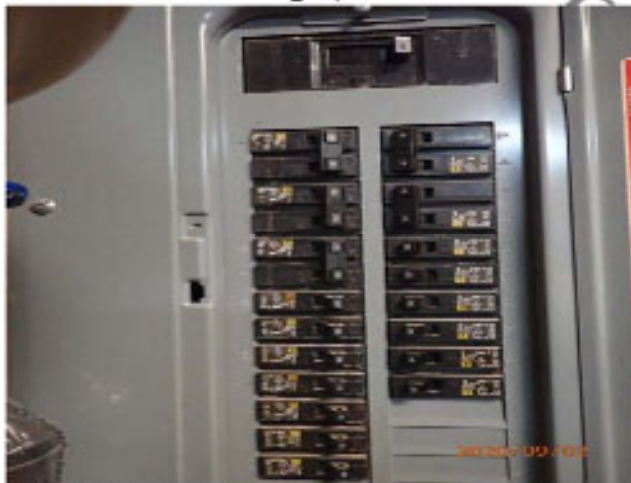
Breaker Panel.

- **AFCI (Arc-Fault Circuit Interrupters)** are now required to be installed on all single-phase, 15 and 20 amp breaker that are not connected to a **GFCI**: Example, Family Room, Dining Rooms, Living Rooms, Bedrooms, Closets, Hallways, and similar rooms or areas.

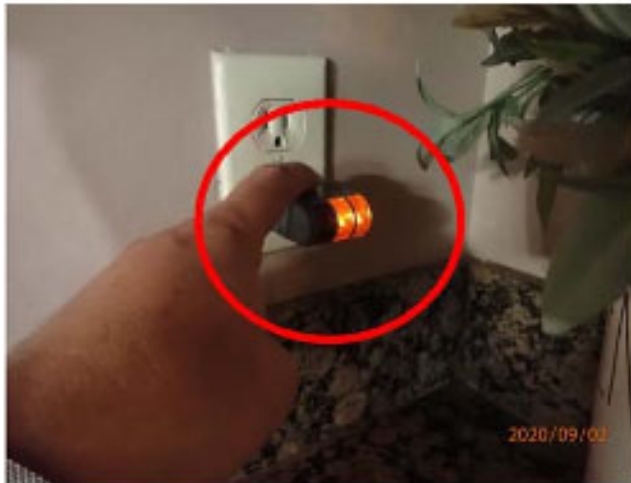
- The installation of a ground fault circuit interrupter in the kitchen (GFCI) is recommended. A ground fault circuit interrupter (GFCI) offers protection from shock or electrocution.

Kitchen counter top outlet not GFCI protected.

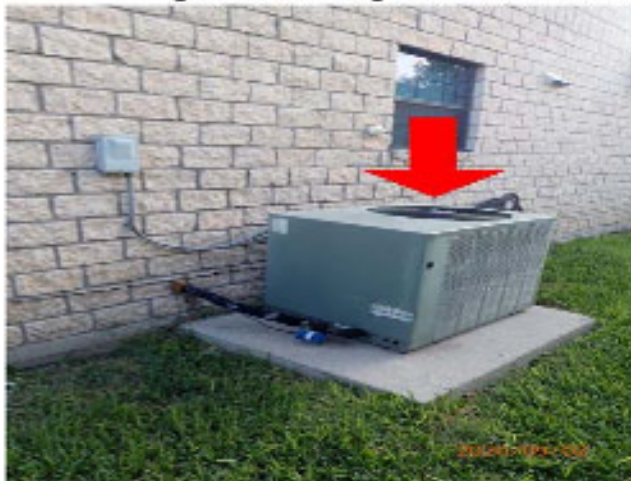
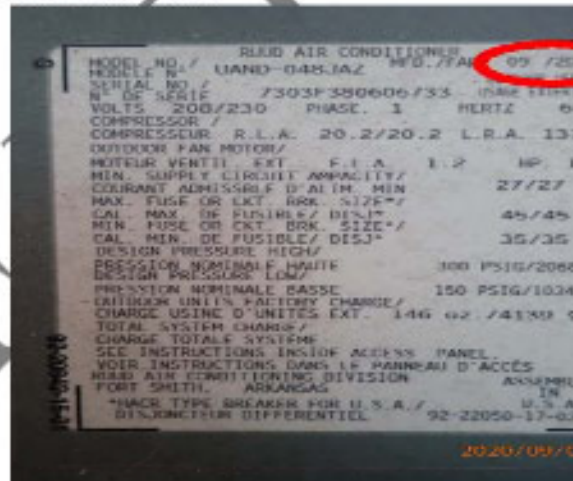
Outside condensing unit.

- The air conditioner was operating normally on the day of the inspection, but is aging and should have routine maintenance performed and budget for replacement at some point in the future.

Outside condensing unit MFD: 09-2006

- Recommend licensed HVAC technician to perform regular maintenance in unit.

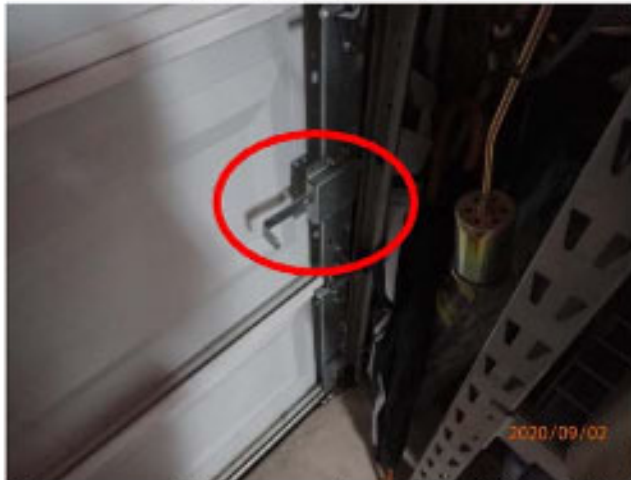
- It is recommended to remove the garage door lock when an automatic opener is installed. Locking the door and operating the garage door opener would result in considerable damage to the garage door.

It is recommended to remove the garage door lock when an automatic opener is installed.
